RepDPF

Repair set, pressure line

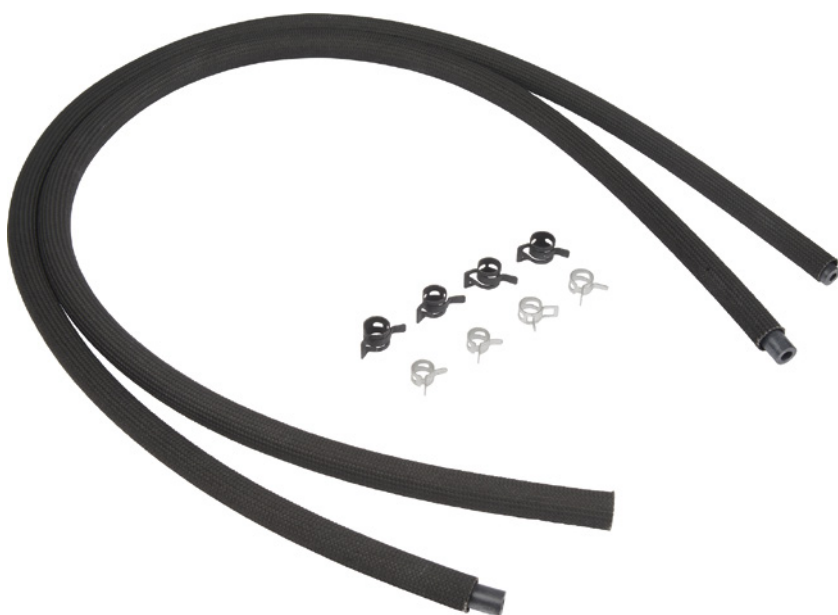
Using this repair kit, defective connecting hoses between the diesel particle filter (DPF) and the differential pressure sensor can be quickly and simply replaced. Pine marten bites may also be responsible for damage, and not just mechanical and thermic influences. That's why this set is supplied with protective hoses

that are resistant to both high temperatures and pine marten bites. They protect the silicone pressure lines from external influences. The spring band clamps included in the scope of supply ensure that the hoses are held securely.

Material: Silicone
Info: with connection line
 with protection hose
 with marten protection
 with clamps
